BUFFETING OF EXTERNAL FUEL TANKS AT HIGH SPEEDS

ON A GRUMMAN F7F-3 AIRPLANE

By Howard L. Turner

NACA RM No. A7A07

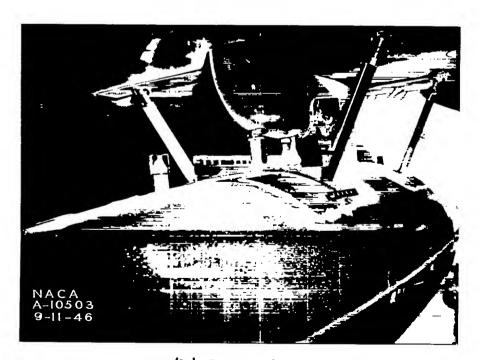
Figure 4.- Wing position, sway brace, configuration 2.

Configuration 2.- For configuration 2, which differed from configuration 1 only in the degree of fairing of the sway braces, the flow characteristics were essentially the same as for configuration 1. Flow separation and its accompanying tank shaking occurred at a Mach number of 0.620, 0.02 lower than for configuration 1.

- (a) Flat strap-type sway brace, no fairing
 - (b) Steel streamlined tubing auxiliary sway braces
 - (c) Rubber, 3/32-inch-thick, between sway brace and tank

- (d) Adjustment screws torqued to exert a force of 9000 pounds per sway brace on tank
 - Note: Pylon access hole, shown open in figure 4 was closed during flight tests.

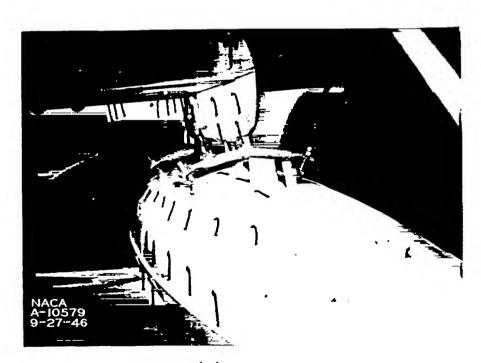
Figure 6.- Wing position, sway brace, configuration 4.

Configuration 4. - Configuration 4 differs from configuration 3 only in its lateral rigidity. The flow characteristics are essentially the same as for configuration 3. Flow separation occurred at M≈0.60 but the tank shaking began at 0.529, while the tufts indicated severe turbulence or incipient separation. The shaking of configuration 4 before flow separation occurred was believed to be accentuated by the relatively low lateral rigidity of the installation.

- 4. Service-type sway brace (fig. 6)
 - (a) Round service-type sway braces
 - (b) Rubber removed from sway brace pads
 - (c) No auxiliary braces
 - (d) Adjustment screws torqued to exert 13,000 pounds per sway brace on tank

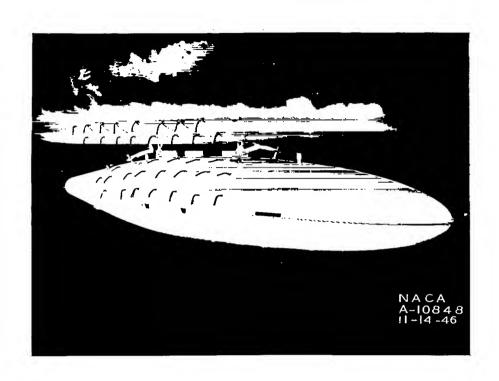
Figure 7.- Fuselage position, sway brace, configuration 4.

Fuselage mounting. The shaking of the tank in the fuselage position was found to be similar in magnitude and characteristics to the shaking realized in the wing position. No shaking of the airplane was noted by the pilot. The tuft pictures indicate an incipient separation along the top of the tank and aft of the rear sway brace at Mach numbers of approximately 0.685. The tank position recorder indicated that the tank started to shake slightly at this time. The dives were continued to Mach numbers of approximately 0.725. The dives were terminated at these speeds because the pilot believed he had reached the limit diving speed of the airplane with the tank on. Only a slight tremble was felt in the airplane at these speeds.

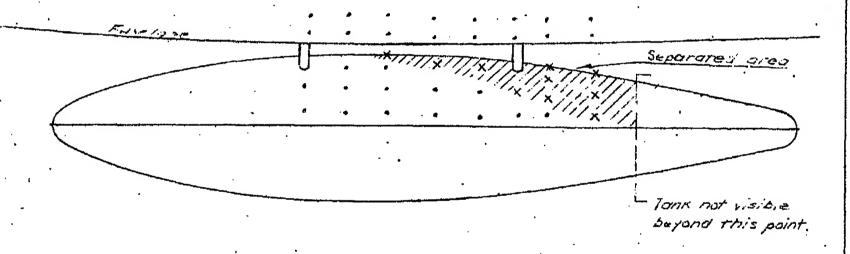
Figure 9 is a sketch of the tank suspended below the wing showing the maximum area of flow separation on the fuselage side of the tank for all configurations tested. This area was determined from the motion pictures and from the marks left on the tank by the severely oscillating tufts.

Figure 9 indicates that the flow separation in the wing position extends forward to a point between the front and rear sway braces at approximately 30 percent of the wing chord. Since the maximum thickness of the wing is at approximately 30 percent of its chord and the maximum thickness of the tank is just below this 30-percent-chord point, it was decided to compute by the method of reference 1 the velocity distribution in this area in an attempt to obtain a value of the critical Mach number in that region.

Fig 9. Flow separation at high speed around an auxiliary fuel tank mounted under the wing of a Grumman FTF-3 airplane. M = 1.640

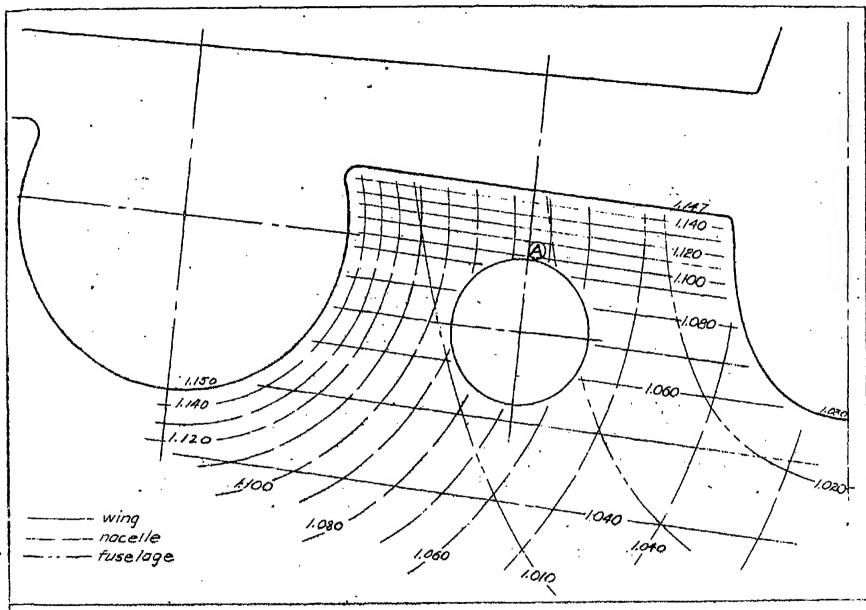
At the maximum Mach numbers attained, the separated area had extended forward and downward from the rear sway brace area. Figure 10 shows the area of flow separation at these maximum speeds. At no time was the flow separation as violent as that observed in the wing tests. No separation was indicated along the fuselage.

Figure 11 shows the result of the analysis of the velocity distributions at a station 30 percent of the wing chord and in the area between the right engine nacelle and

the fuselage. Assuming the nacelle and fuselage to be bodies of revolution with definite fineness ratios, lines of constant velocity ratio were drawn for the nacelle, fuselage, and wing (references 1, 2, and 3). From these velocity distributions and using the method of superposition and interference shown in reference 1, it is possible to calculate a low-speed pressure coefficient from which a value of critical Mach number may be determined. (See fig. 4, reference 1.) For example, the critical Mach number at point A figure 11, neglecting interference due to sway braces and power effects, would be as follows:

0.590. This calculated critical Mach number is in good

agreement with the Mach number at which the violent disturb
ances in flow were indicated by the tuft studies. The power

Fig. 10 - Flow separation at high speed around an auxiliary fuel tunk mounted under the fuselage of a Gruniman F7F-3 airpiane.

Fig. 11 - Velocity-ratio distribution in the region of the wing external store attachment position. 30% wing chard, Grumman FTF-3 airplane.
